GEOMORPHIC ASSESSMENT OF THE MARGAREE RIVER MARGAREE SALMON ASSOCIATION

Report Prepared for:
MARGAREE SALMON ASSOCIATION

Prepared by:
MATRIX SOLUTIONS INC.

September 2017
Fredericton, New Brunswick

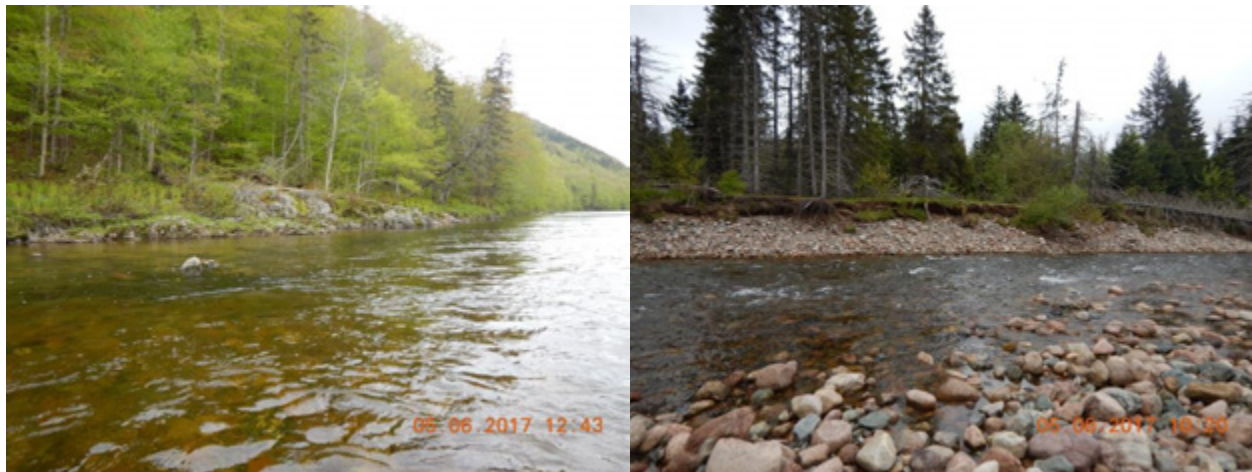
The upper reaches of the Margaree River between Forest Glen Brook and the bridge crossing at Portree were comparatively stable with good aquatic habitat. The majority of these reaches were degrading and in a transitional stability state. This was evidenced by the channel being worn into bedrock, elevated tree roots above the channel bed, cut face on bar forms, and head-cutting of the channel bed. Only the upper reach, upstream of MacKenzie Pool, was in regime. The river was found to be over-widened and shallow in a reach from Wards Rock to Black Rock Pool, particularly in front of the Big Intervale Fishing Lodge. A few areas of channel migration and excessive erosion were noted in this stretch of river.

Figure 5. Exposed bedrock and elevated tree roots in upper reaches of the Margaree

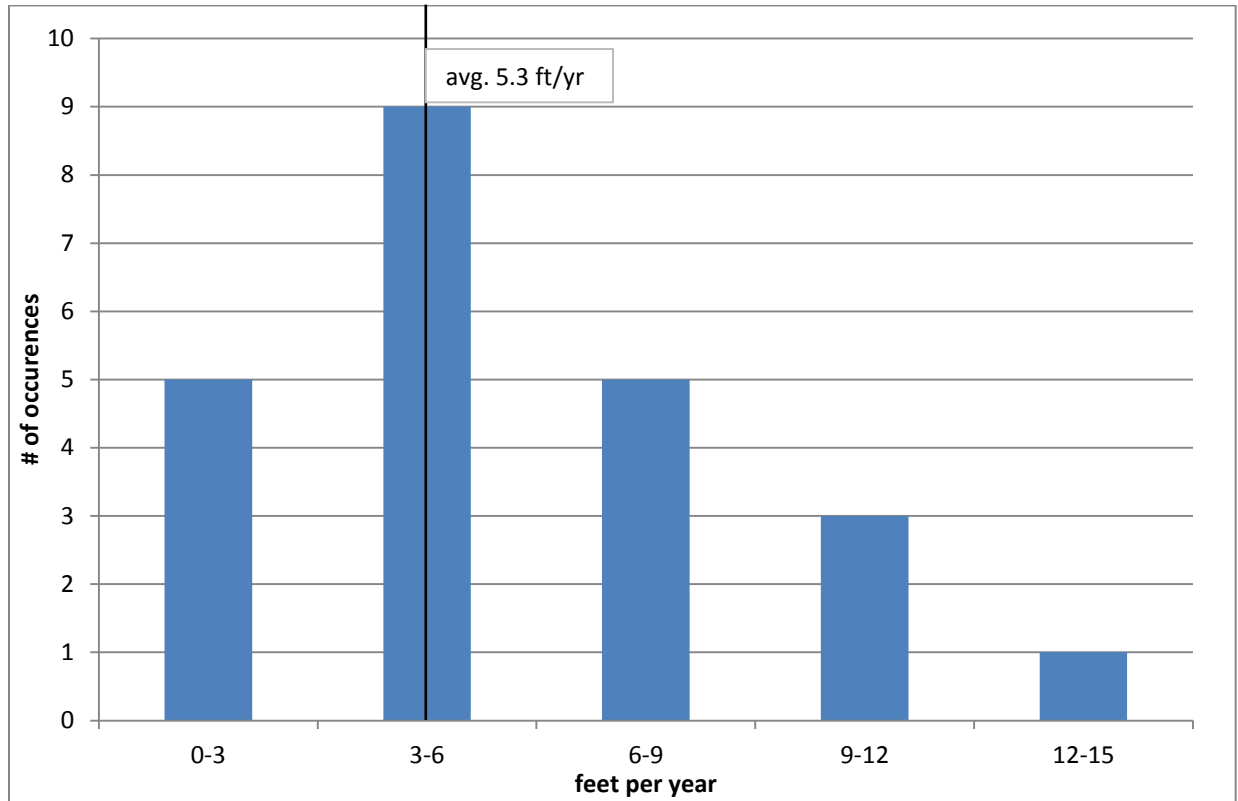
Upstream of MacKenzie Pool, at the upper extent the assessments, the outer bend of the main channel of the Margaree River is extending further into the bank when compared to 1984 imagery. The migration rate at this bend, approximately 6 feet per year, is comparable to migration rates calculated at outer bends throughout the assessed reaches and is slightly above the average (approximately 5 feet/year). Migration rates were calculated by comparing distances between the apex of outer bends and fixed points, such as buildings or roads, on 1984 and 2013 imagery (Figure 6).

Figure 6. Outer bend migration rates on the Margaree River

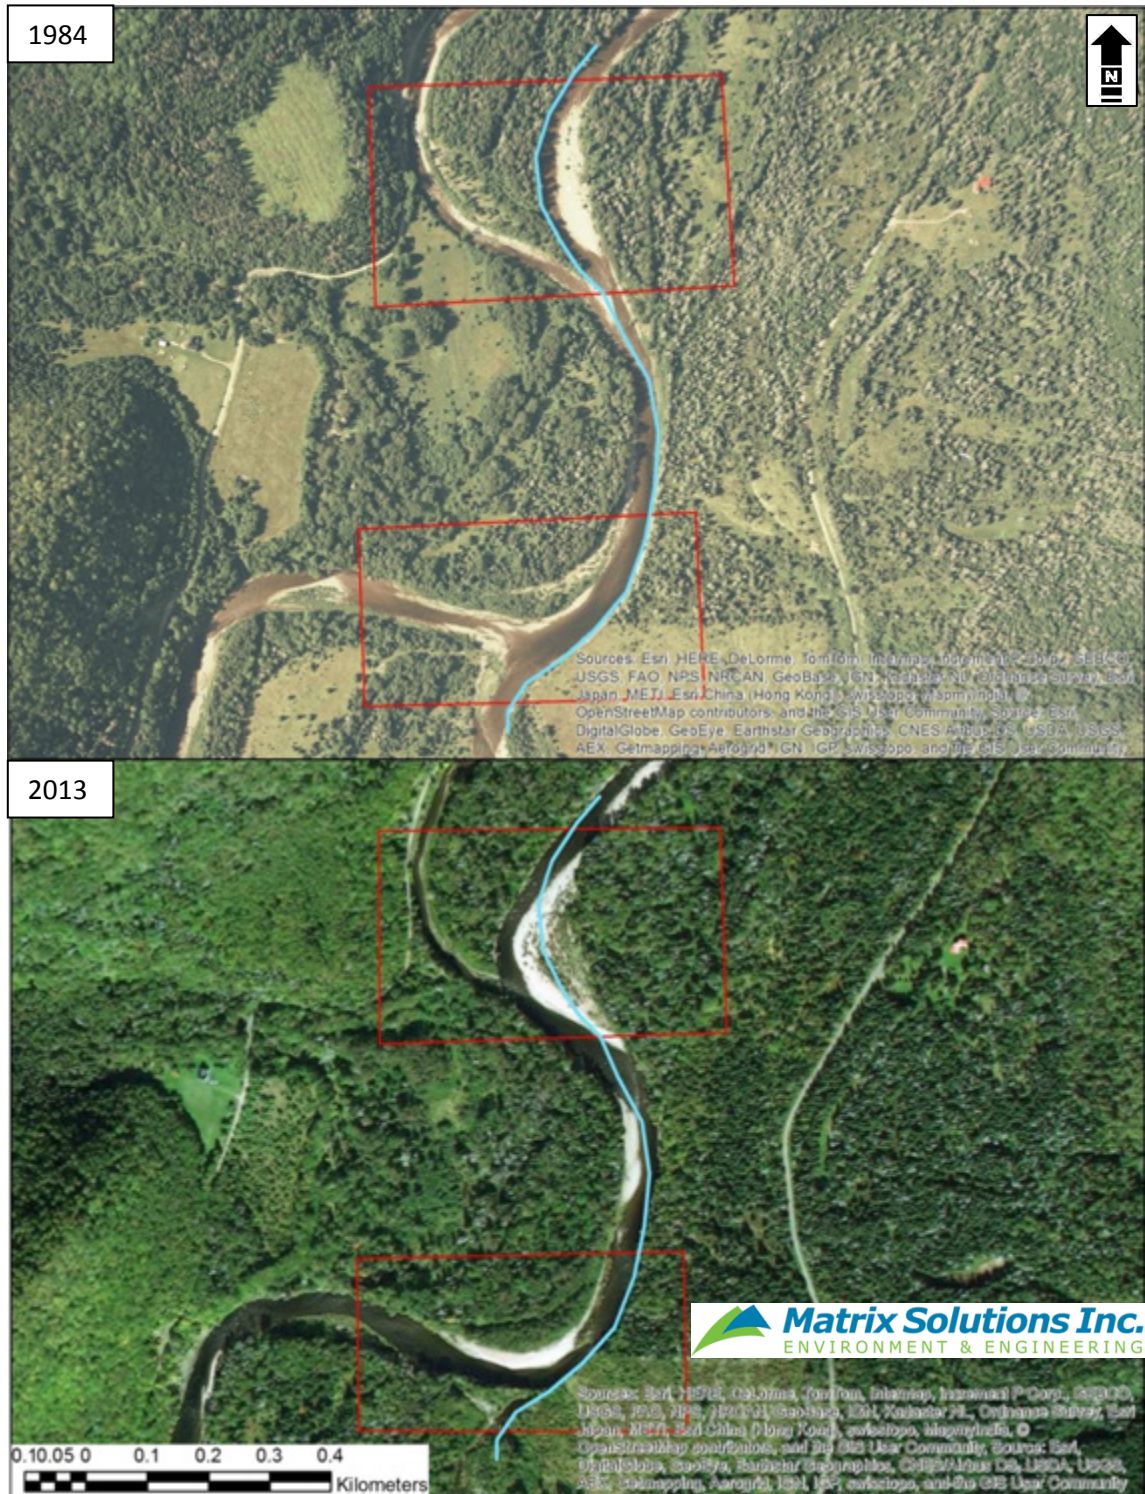
Also, the main channel of the Margaree had previously cut through the floodplain at MacKenzie Pool. Barring human intervention, the new channel would have cut off the previous channel and changed the conditions of MacKenzie Pool. A rock wall was installed to prevent the new channel from going through the floodplain and keep the pool where it was. The migrating channel upstream may, in turn, put pressure on the bank upstream of the rock wall and cause instability; however, the bend immediately upstream of the wall has not migrated significantly since 1984 and is relatively stable (Figure 7).

Figure 7. Channel migration in upper reach of Margaree River

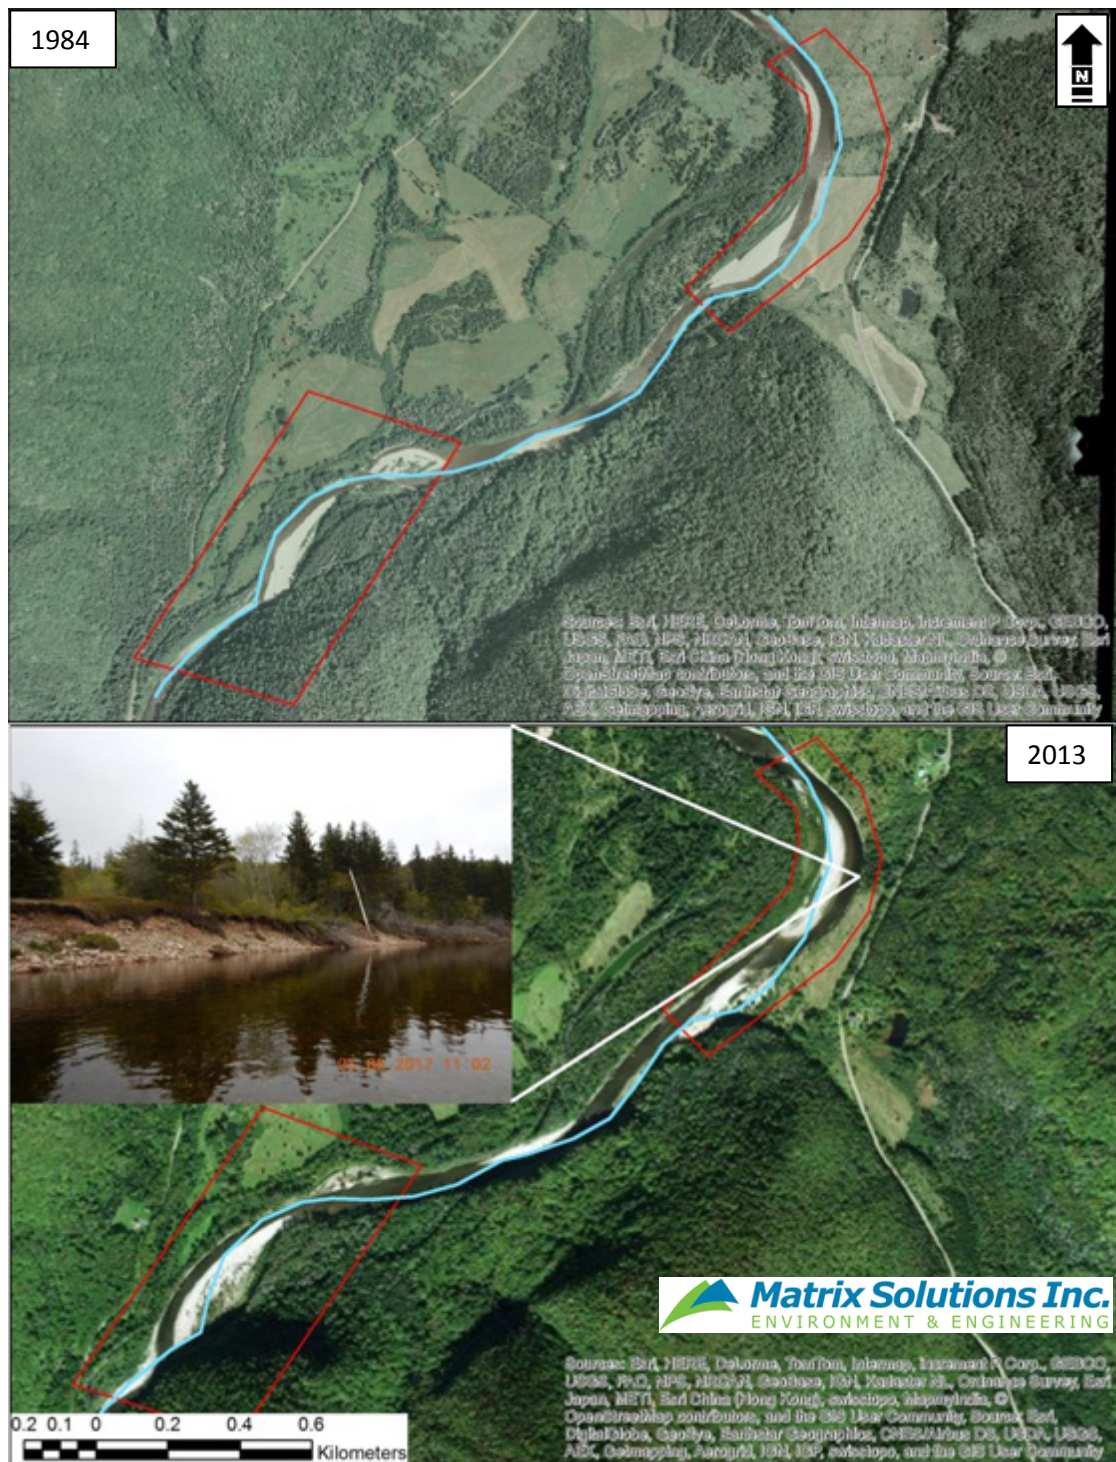
The channel is also migrating at approximately 8 feet per year, 3 feet above the average, in the outside bends between Cemetery Pool and wards rock pool (Figure 8). The outer bend at Cemetery Pool has

eroded far enough to jeopardize an existing powerline (a power pole has fallen from the bank and is standing nearly within the main channel).

Figure 8. Channel migration between Cemetery Pool and Wards Rock

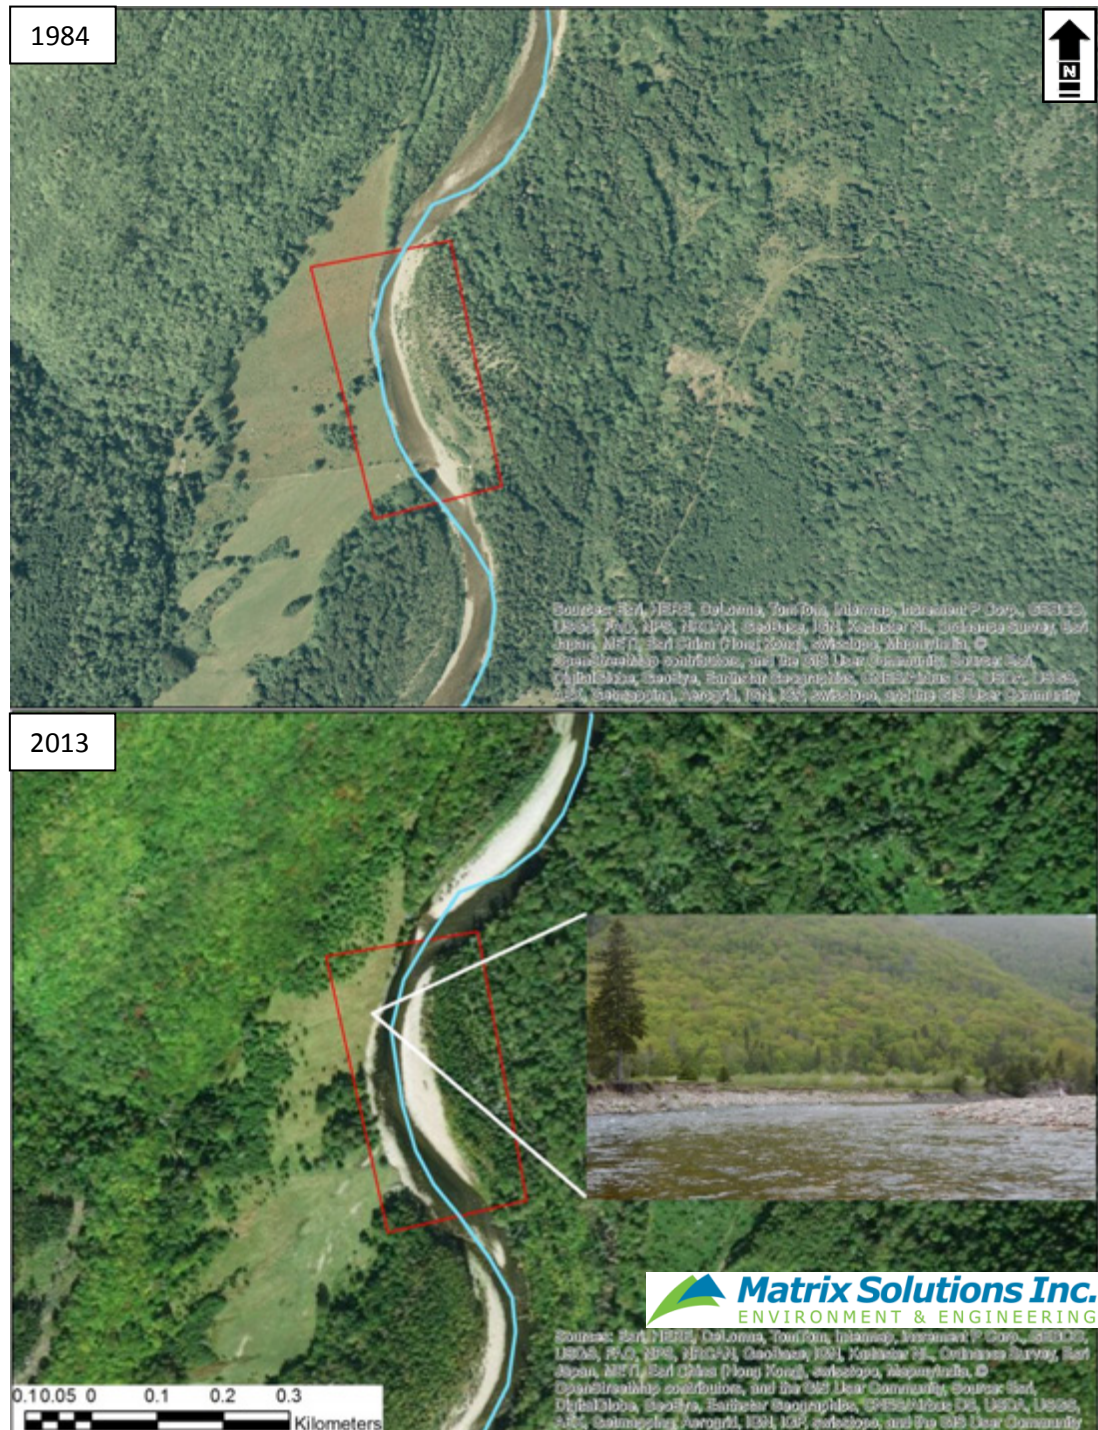
Just upstream of the Portree bridge, adjacent to an apple orchard, another rapidly eroding bank was noted. This bend is eroding at a rate of approximately 3.5 feet per year, lower than the average of 5 feet per year. However, a rock wall installed at the upstream extent of the bend may accelerate erosion downstream in the unprotected sections of the bend (Figure 9).

Figure 9. Eroding outer bend upstream of Portree Bridge

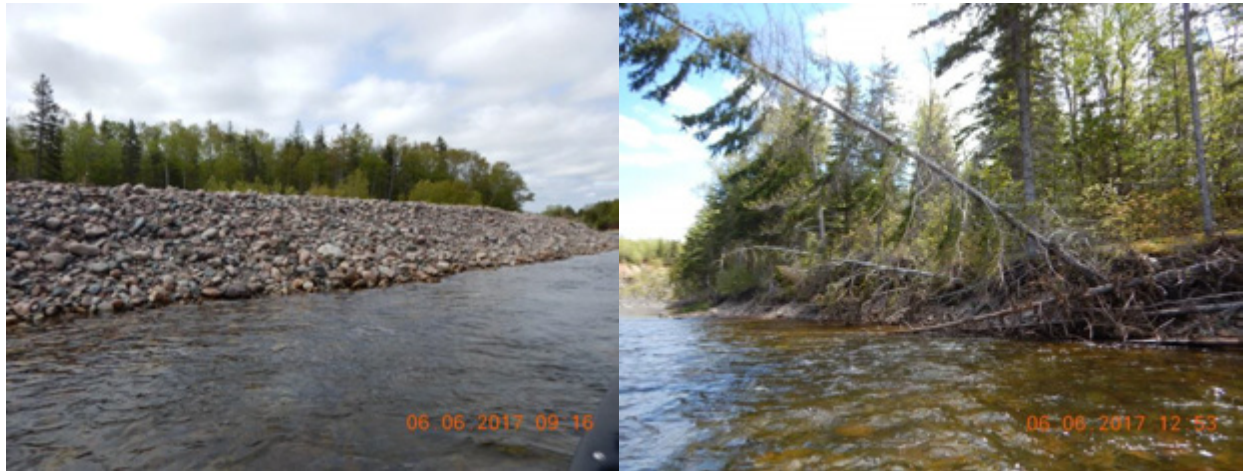
The reaches of the Margaree River between the bridge crossing at Portree and the bridge crossing at Cranton Crossing were the most unstable when compared to other assessed reaches. The majority of these reaches were widening and in a transitional stability state. This was evidenced by fallen/leaning trees/fence posts/etc., occurrence of large organic debris, steep bank angles, basal scour on inside meander bends and fracture lines on top of the banks. See Figure 12 for images of a couple of the indicators of widening discovered in these reaches. The most unstable reach of all the assessed reaches is located in this section of river. It is located downstream of the fish hatchery, from the confluence of

Ingram brook to the hydrometric station, where the channel splits into three then converges into a single channel again. Areas of channel migration and excessive erosion were also noted in this stretch of river.

Figure 12. Indicators of widening in channel reaches (basal scour on inside bend in left image, fallen and leaning trees on the right)

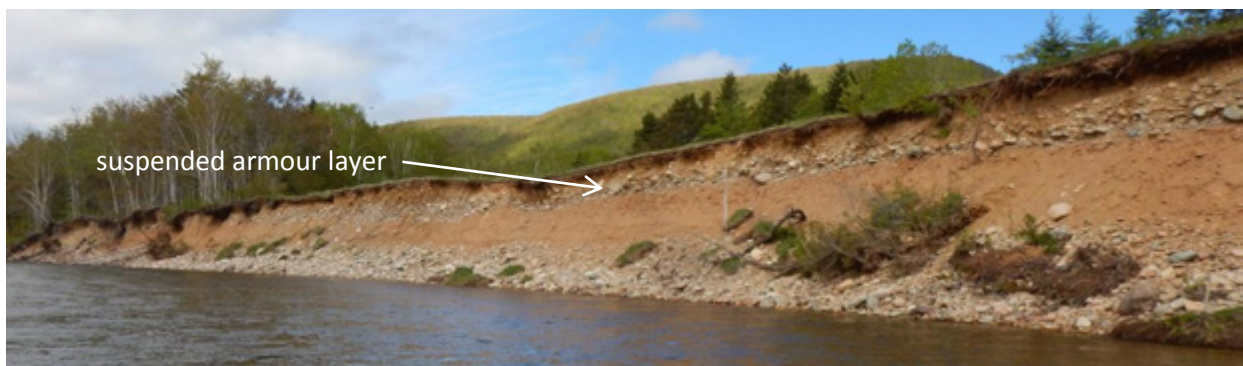
Downstream of the Portree Bridge, the first outer bend on the right bank of the main channel of the Margaree River is extending further into the bank when compared to 1984 imagery. The migration rate at this bend, 5.1 feet per year, is comparable to migration rates calculated at outer bends throughout the assessed reaches and is about average (approximately 5 feet/year). However, it was noted that this section in particular was excessively downgrading, cutting deep into the channel bed (Figure 13). This was observed by suspended armour layers suspended in the bank. Though the outer bend migration is within a comparable range to other reaches, the amount of bed degradation indicates that this section is unstable and contributing to sediment inputs downstream.

Figure 13. Suspended armour layer in reach 9, just downstream of Portree Bridge

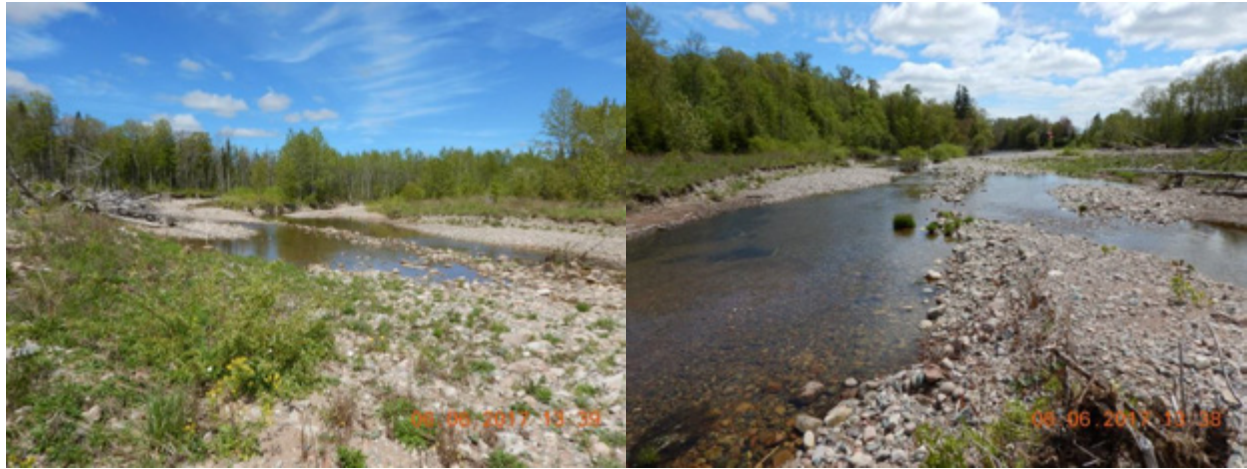
The most unstable reach, reach 13, from the confluence of Ingram Brook to the hydrometric station just upstream of the Crowdis Crossing Bridge is undergoing planform adjustment brought on by excessive aggradation. This was evidenced by multiple channels, chutes, cut off channels, poorly formed bars, as well as excessive deposition on the bars, in the channel bed and in the overbank zone. Figure 15 includes photographs taken from this reach. See Figure 16 for comparisons between 1984 and 2013 imagery. Though the evidence of planform adjustment is widespread, the migration rates through this reach were comparable to other reaches.

Figure 15. Reach 13 photographs

With an average outer bend migration rate of 5.3 feet per year bank restoration projects should target areas where the outer bend migration rates exceed this ratio. Reach 13 for instance has been noted as the most unstable reach with outer bend migration rates calculated at 12 feet per year. As well Reach 13 is located between Portree and the Cranton Bridge crossing and according to the Agriculture and Agri-Food Canada's soil landscapes of Canada, the soils are more erodible compared to soils underlying the upstream reaches. Restoration projects that focus on the reduction of sediment input from this section of the Margaree River should be considered.

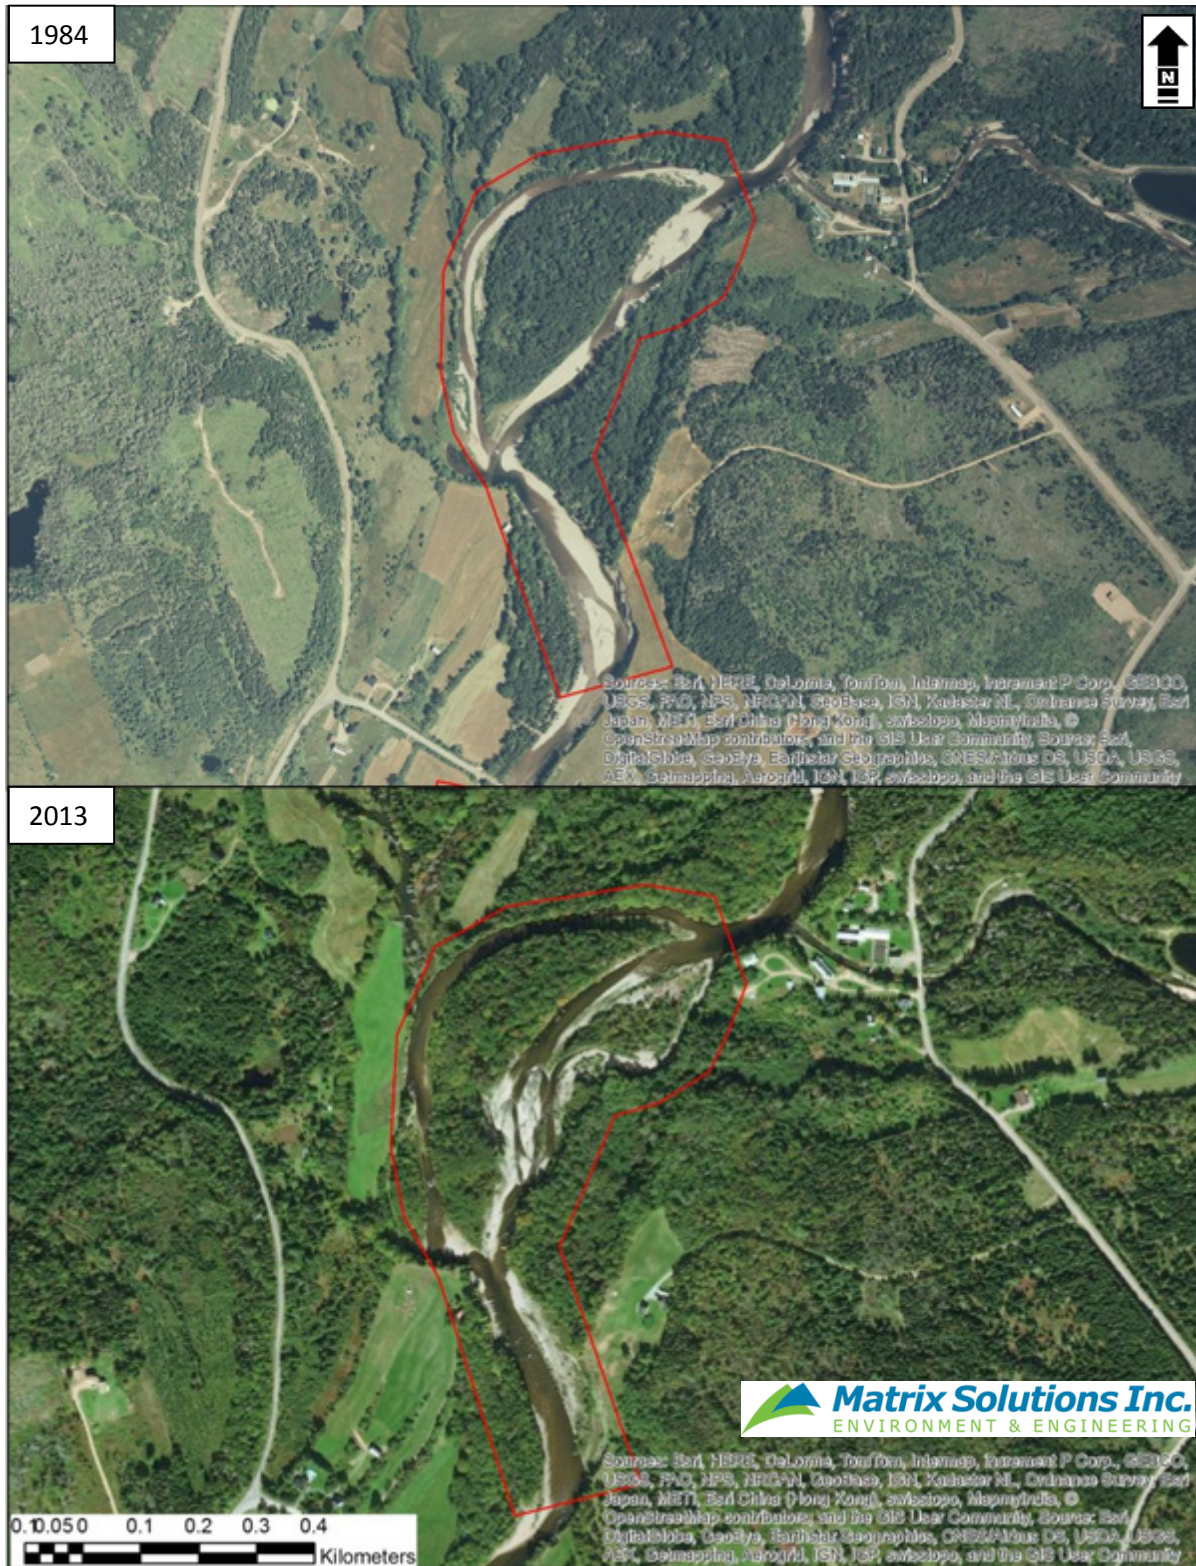
Figure 16. Reach 13 aerial photographs

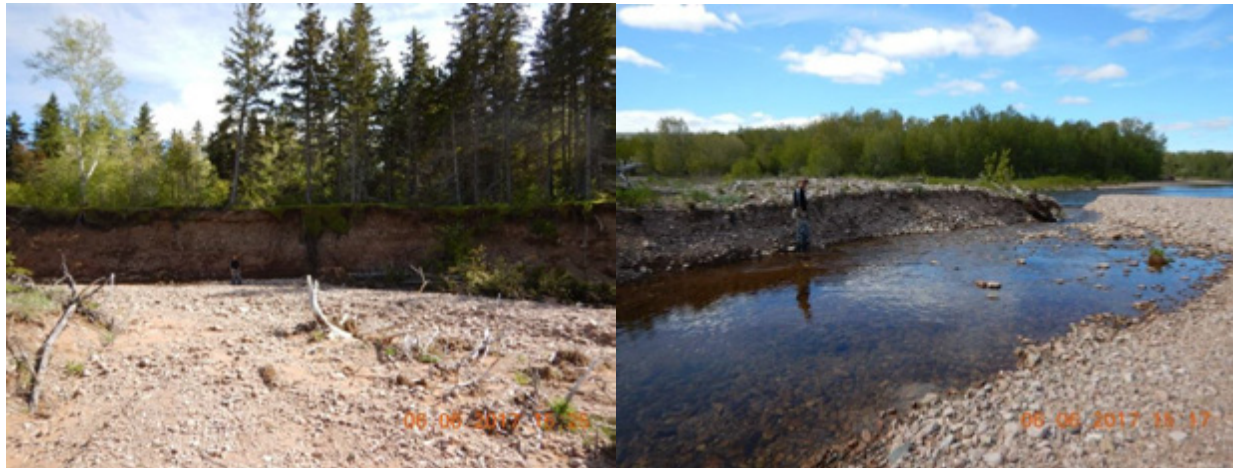
Another area of instability with the stretch between Portree Bridge and Cranton Crossing was noted at the mouth of Nile Brook and downstream of the brook confluence. The mouth of the brook itself was highly elevated from the river, severely aggraded, with cut face on bar forms, braided channels and high eroding banks. The mouth of the brook was not assessed for geomorphic conditions but photographs were taken. See Figure 17 for pictures of the mouth of Nile Brook.

Figure 17. Nile Brook confluence

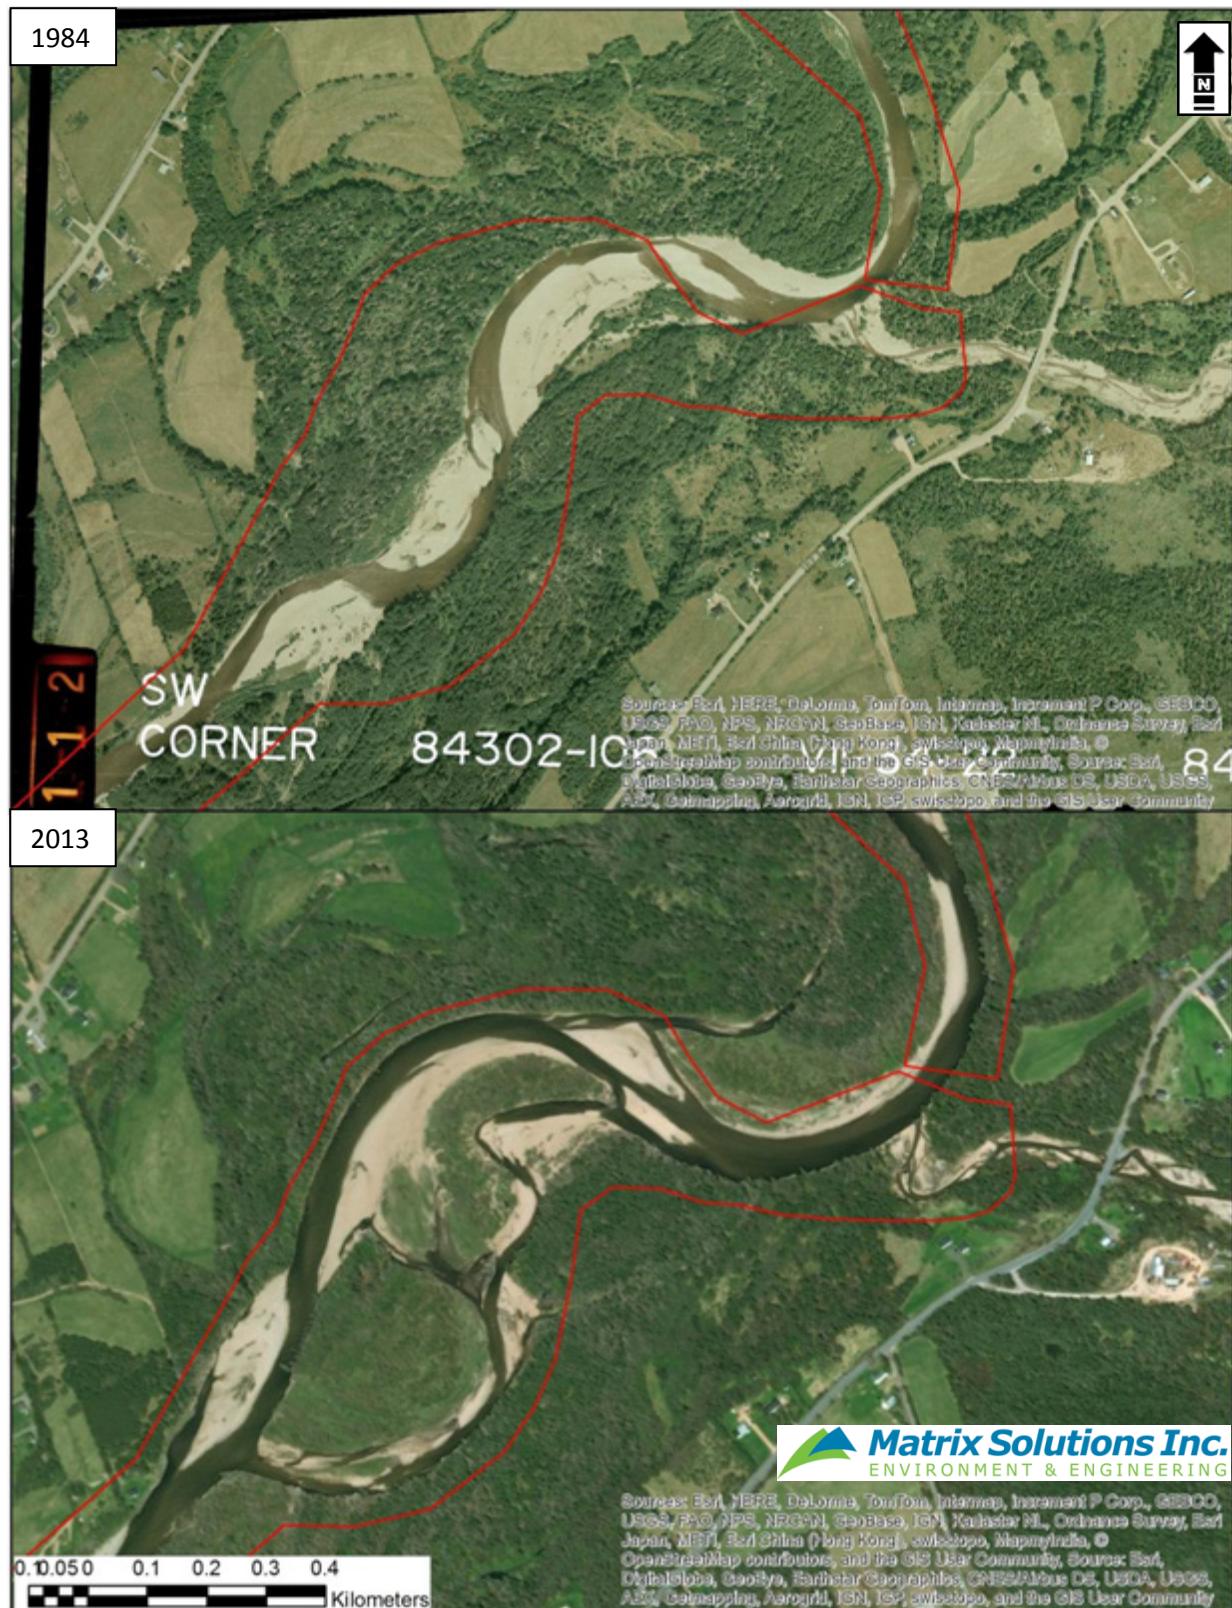
The migration rate of the last outer bend in the brook before it meets the river is 6ft/yr, approximately 1 ft/yr more than the average in the river. Another rapidly migrating outside bend in the same located in the river just downstream of the Nile Brook confluence on the next turn (right bank). The outer bend in this location has migrated the most compared to other bends, and also moved slightly downstream. It is estimated that this bank is migrating at approximately 12 feet per year, despite the bank being well vegetated. Refer to Figure 18 for comparisons between 1984 and 2013 imagery of the area.

Figure 18. Aerial imagery of Nile Brook confluence and downstream

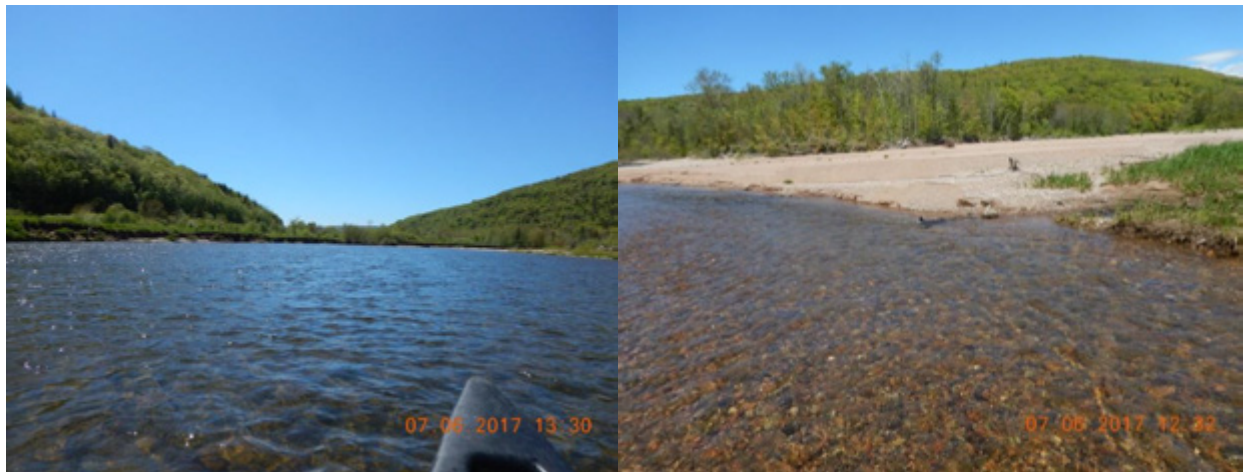
The stretch of river between the Cranton Crossing Bridge and the Southwest Margaree River were also relatively unstable. Reaches were mostly in a transitional state and the remaining sections were in adjustment. The dominant geomorphic processes alternated between widening and aggradation. The majority of these reaches were widening and in a transitional stability state. This again was evidenced by fallen/leaning trees/fence posts/etc., occurrence of large organic debris, steep bank angles, basal scour on inside meander bends and fracture lines on top of the banks as well as excessive deposition in the channel bed and banks. See Figure 19 for examples of geomorphic indicators observed in these reaches.

Figure 19. Representative photographs from reaches between Cranton Bridge and SW Margaree

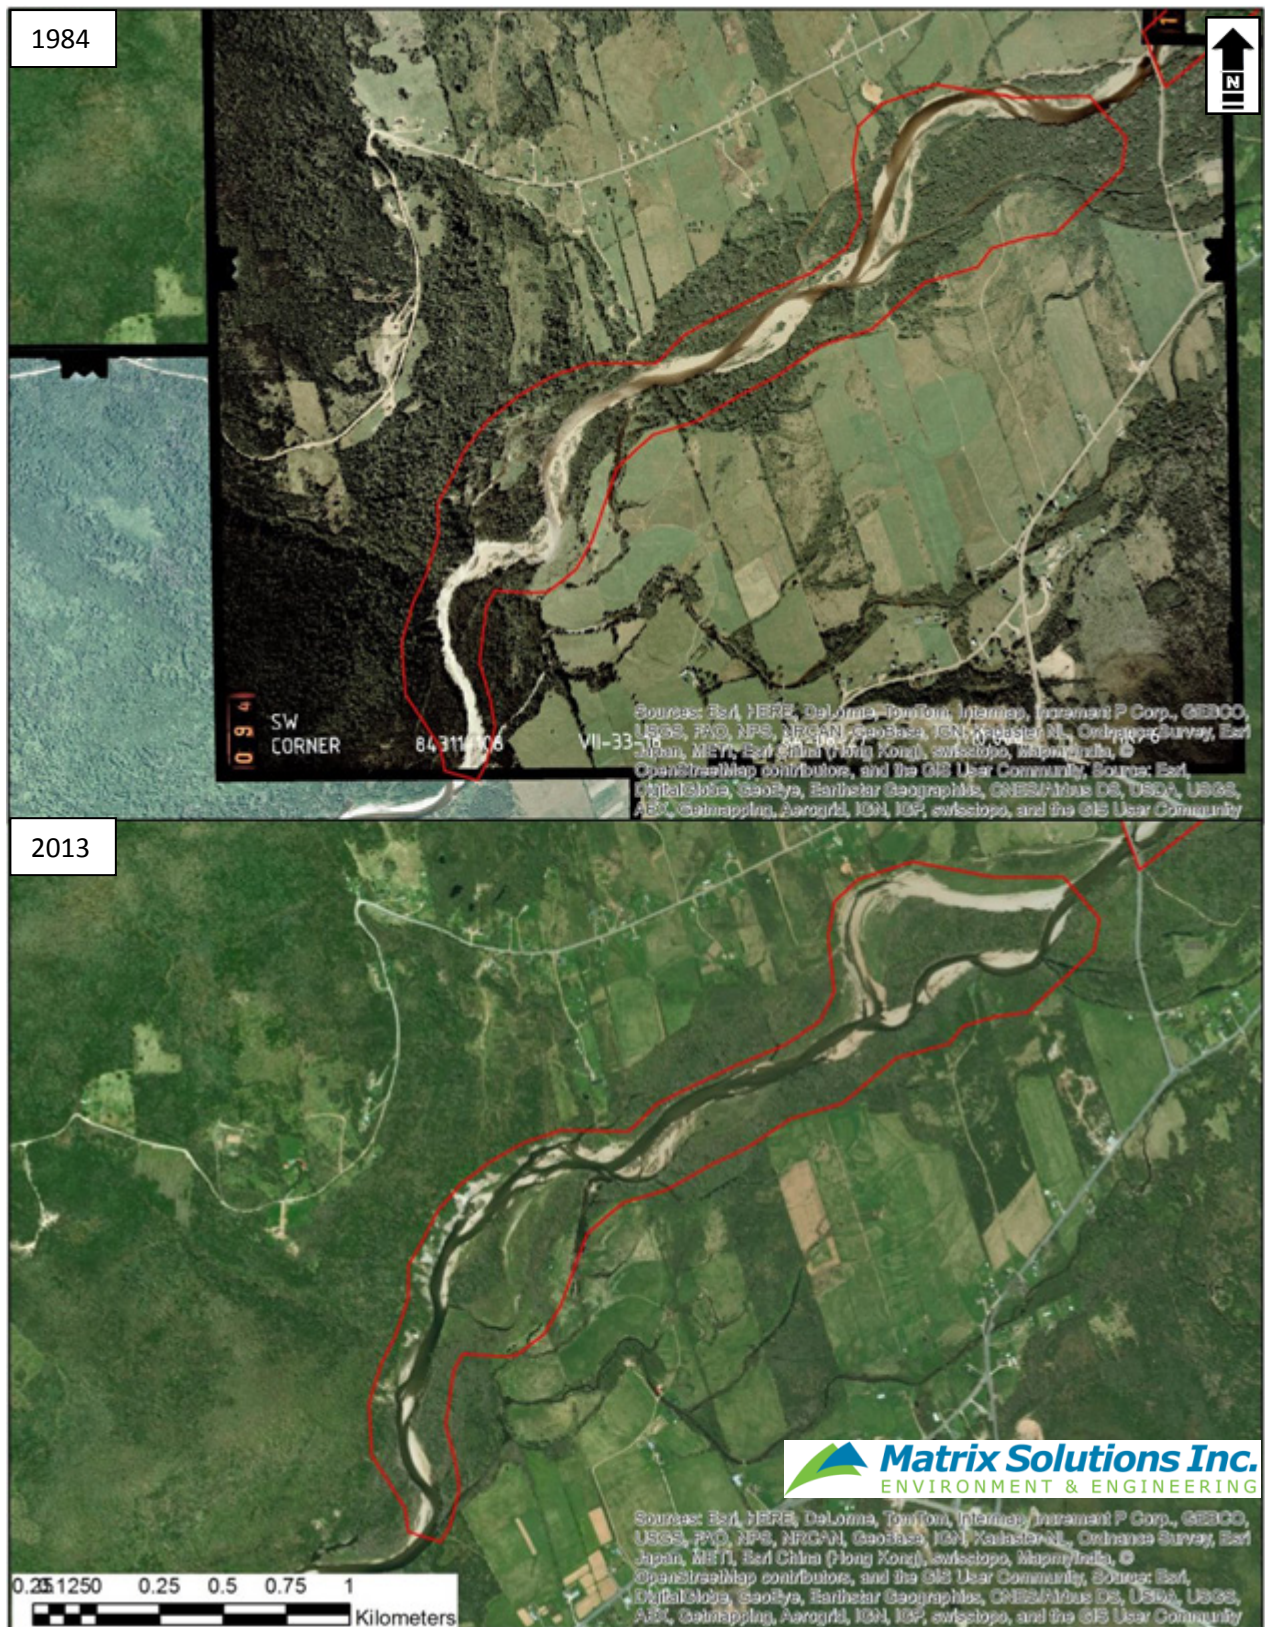
Areas of channel migration and excessive erosion were also noted in this stretch of river. Migration rates of the outside bends in this section of river were close to the average. Changes in channel planform were frequent, with the river splitting into multiple channels and abandoning old channels for new ones. This was particularly in reaches 18 and 19 between Cranton Crossing Bridge and the confluence of Lake O'Law Brook. See Figure for an aerial comparison of the Margaree River between Cranton Crossing Bridge and Lake O'Law Brook for 1984 and 2013.

Figure 20. Reach 18 and 19 aerial imagery

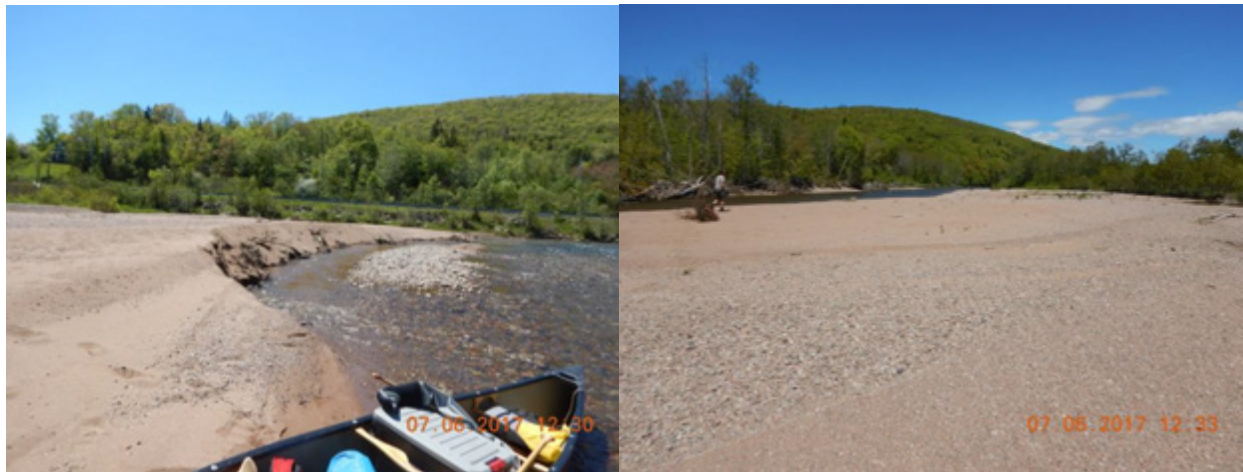
Another area of note in this section of river was in reach 22, at the confluence of Big Brook. This reach was heavily aggraded, with excessive depositions at the mouth of Big Brook. This is likely due to the river coming to a sharp bend as it meets the Cabot trail. As the river comes into this hard bend and hits the riprap along the bank/road berm, the flow is abruptly slowed, allowing material to drop out of suspension. Some material may be originating from the brook and dropping out at the confluence as well.

Figure 21. Big Brook confluence

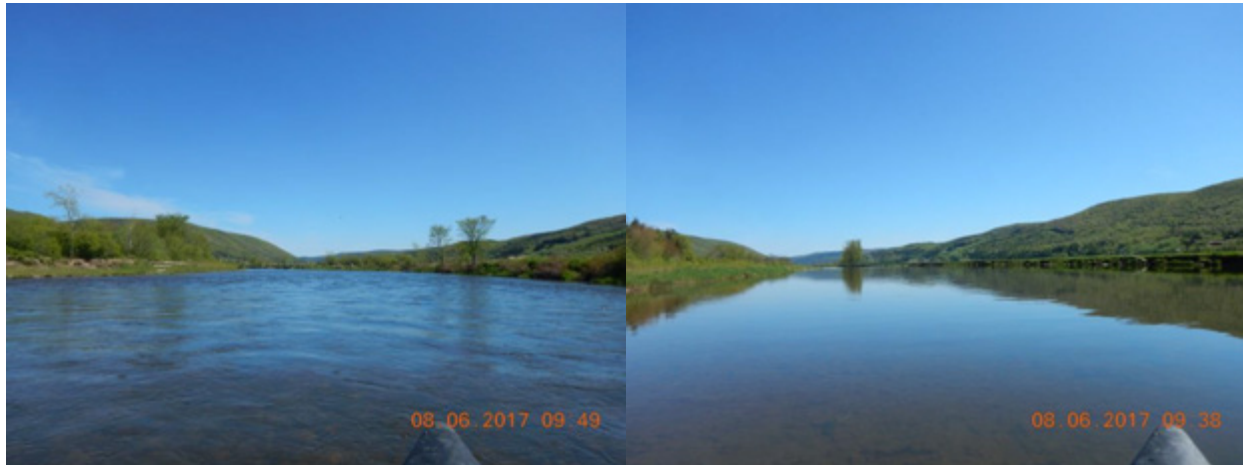
The remaining reaches contain the lower portion of the river. These were also transitional and in adjustment as well as aggrading and widening. Some aggradation and channel widening would be typical in the lower reaches of a major system, especially with the addition of a major tributary such as the Southwest Margaree River; however the number of geomorphic indicators identified indicates these lower reaches are also experiencing instability outside the normal range expected. The riparian zones in this section of river have been altered to open agricultural lands and some bank erosion was noted. With the lower slope and therefore reduced energy, the migration rates in these reaches were comparable or lower than the average compared to other outside bend migrations. Long stretches of river from the SW Margaree confluence to the Tidal Pool were without good pool habitat due to the excessive deposition in the channel bed. Increased turbidity was also noted originating from the Southwest Margaree River, which may be due erosion upstream in the system. Erodible soils also underlie the majority of the main channel of the SW Margaree. See Figure 22 and Appendix E for representative photographs of these reaches.

Figure 22. Representative photos of Margaree River between Southwest confluence and Tidal Pool
