Stream Bank Protection Project

An information source for implementing stream bank protection

November 2013

Paul Brenton, Nova Scotia Federation of Agriculture

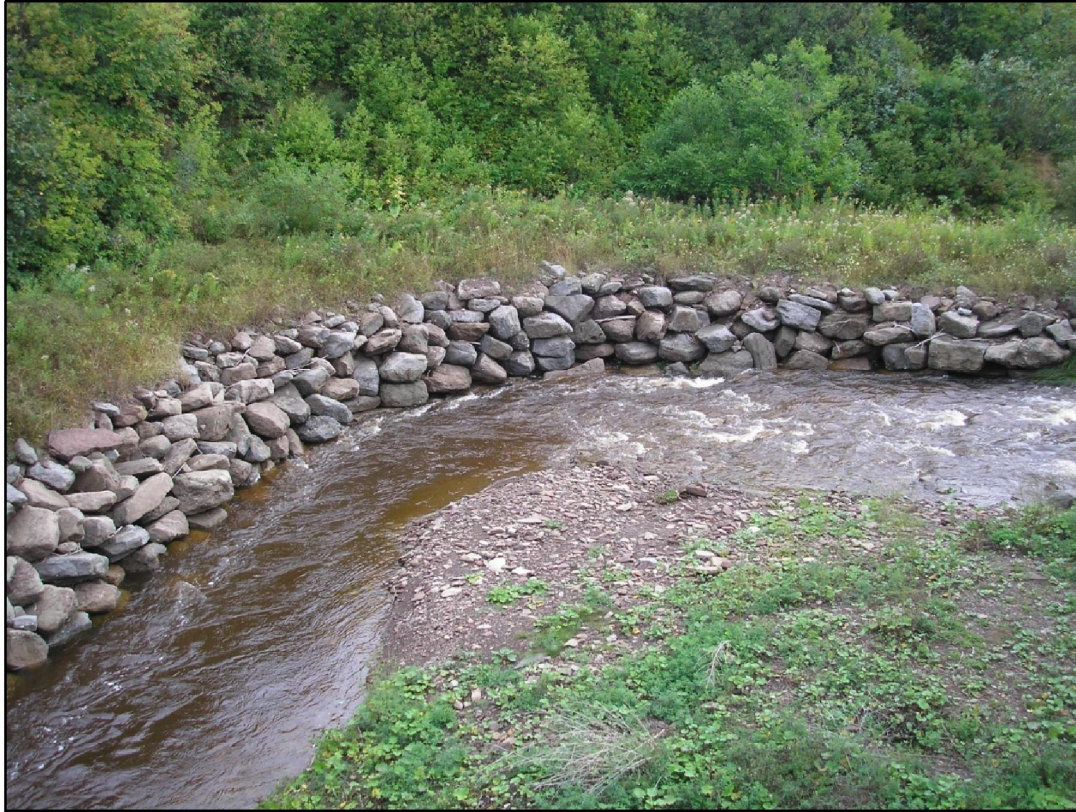
The site at Broad Cove was on a sharp bend in the brook and was designed to protect the bank supporting the adjacent bridge abutment. The rock appeared to be more rounded natural stones than angular quarried rock but there was no evidence of rock movement (see picture on cover).

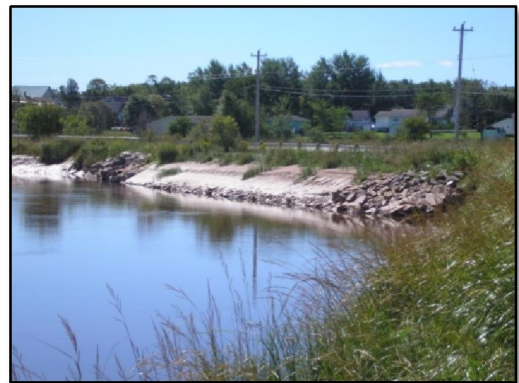
The site, on the tidal section of the Shubenacadie River in the village of Shubenacadie, is located on a bend in the river and was designed to protect the adjacent road. The site has very little room between the road and the river, thus has a steep bank. The stream bank protection consists of 150 feet of gabion mats with 45 feet of armour rock at each end of the gabions. There is a small amount of armour rock at the bottom of the gabions and the stream bank is approximately 10 feet high. The gabion mats are galvanized wire mats that are 30 meters long by 2 meters wide and 0.23 meters thick. This project was constructed in 2011 but there is no sign of damage to the wires of the gabions from floating logs or ice. The bank is stable and silt from the river is covering most of the gabion mats (Figure 1). A factsheet on the construction and performance of this site is available at the following link http://www.maccaferri.ca/media/om_website/canada/Case%20Histories/CAN_NSTIR_Shubie_Hwy_215.pdf

Figure 1. Gabion baskets covered in silt

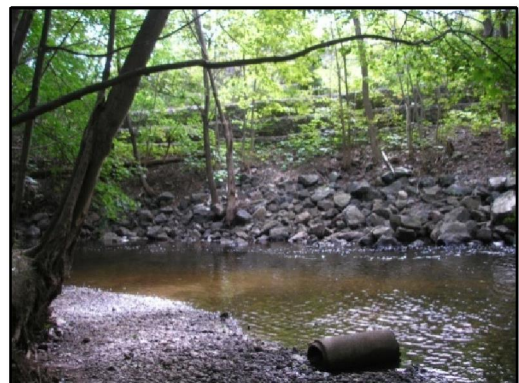
The site on the Brierly Brook in the Town of Antigonish is located on a bend in the brook and was designed to protect the adjacent road. The gabion baskets are stacked approximately 20 feet high with armour rock protecting the bottom six feet of the bank (Figure 2). The bank is very steep and the brook does not flow above the armour rock. The site is over twenty years old and has held up well, however, the gabions cannot be evaluated for abuse as the brook flow does not reach the gabions.

Figure 2. Armour rock and gabion baskets on steep slope

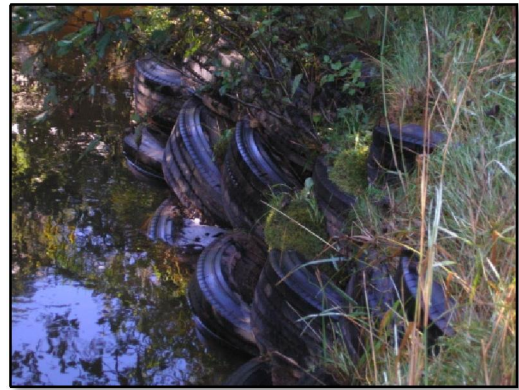
The site is located on a bend in Farnham Brook in Perennia Park (Bible Hill) just upstream from the bridge. The protected area is 40 feet in length and four feet high. This site was constructed in the 1990's. The truck tires were tired together and filled with soil. The tires on the bottom protrude out further into the stream than the tires above them. The bank area is stable and has small trees and grass growing on it (Figure 3).

Figure 3. Vegetation among truck tires

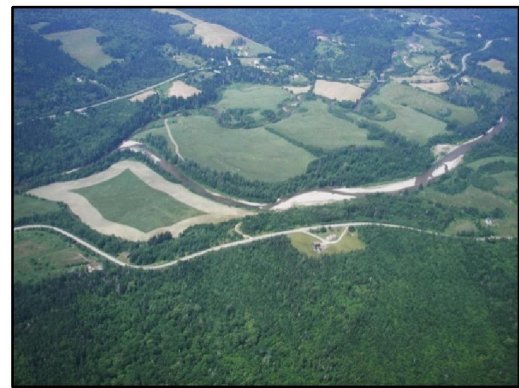
The site on Middle River protects a large interval field on Bruce MacDonald's farm. Most of the armour rock was installed more than twenty years ago. Although many other areas on Middle River have changed course, the river has not moved along this stretch although there are signs of flow across the interval field. There is a twenty foot riparian area consisting of mature trees along the interval field. There are several large gravel deposits in the river along this stretch which would likely cause bank erosion if not for the armour rock and riparian of large trees (Figure 4).

Figure 4. Gravel bars in Middle River

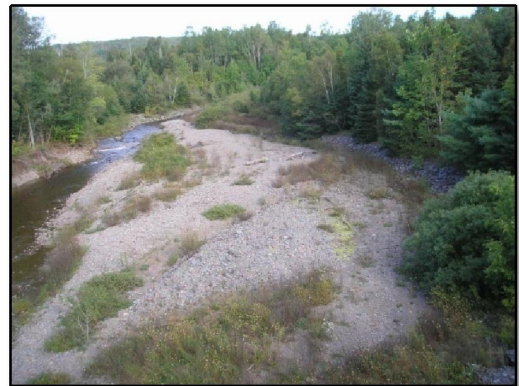
The site on James River located by the TransCanada Highway is on a fairly straight section of the river. This site was armour rocked over twenty years ago. The section north of the highway has had the channel move approximately 70 feet away from the rock bank (Figure 5). The section south of the highway has some signs of bank erosion across the stream from where rocks were placed. Another section has bank erosion above where the armour rock was placed.

Figure 5. Armour rock to the right of gravel bar

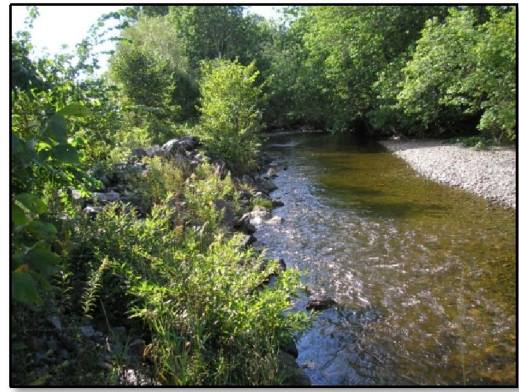
The site on the James River along Wilfred MacDonald's farm is on a small bend in the river. Approximately twenty years ago the river started to cut across an interval field. The armour rock was placed along the old stream bank and the area behind the rock that had eroded was filled in. The rock and the infilled area have stayed well. The protected stream bank is approximately 100 feet long by five feet high and has a lot of small

trees growing amongst the rocks (Figure 6). This site had some erosion across the stream from the armour rock, which appeared to be caused by a large gravel bar formed in the stream.

Figure 6. Trees on rocked bank

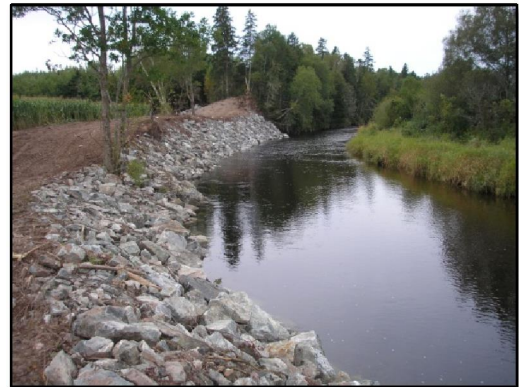
The site on the South River on John Vosman's farm has a gradual bend in the river. This site was just recently completed and had approximately 400 feet of rock that was up to twelve feet high at one end. At this site the lower portion of the bank was being eroded and the trees on the upper portion of the bank were falling into the stream.

Some portions of the bank were rocked at a fairly steep slope that was close to a one to one slope (Figure 7). Care must be taken when placing rock on a steep sloped bank

Figure 7. Steep banks along South River

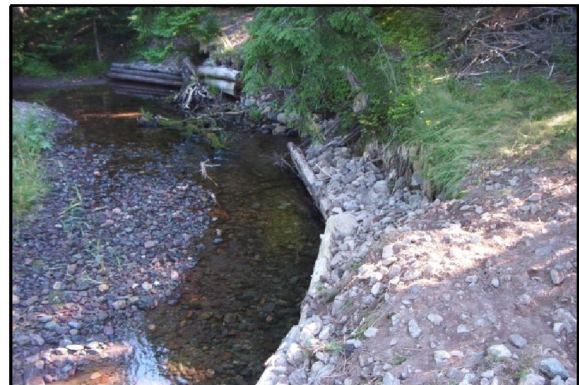
A site is located on the Mill Brook in Earltown at Layton Lynch's farm. The structure has been in place for a few years. Logs placed on their sides on top of one another held in place by several logs on end embedded into the stream bed. This method can be used on steep banks and takes up minimal space in the stream.

Figure 8. Logs along bank of Mill Brook
