GEOMORPHIC ASSESSMENT OF THE MARGAREE RIVER MARGAREE SALMON ASSOCIATION

Report Prepared for:
MARGAREE SALMON ASSOCIATION

Prepared by:
MATRIX SOLUTIONS INC.

September 2017
Fredericton, New Brunswick

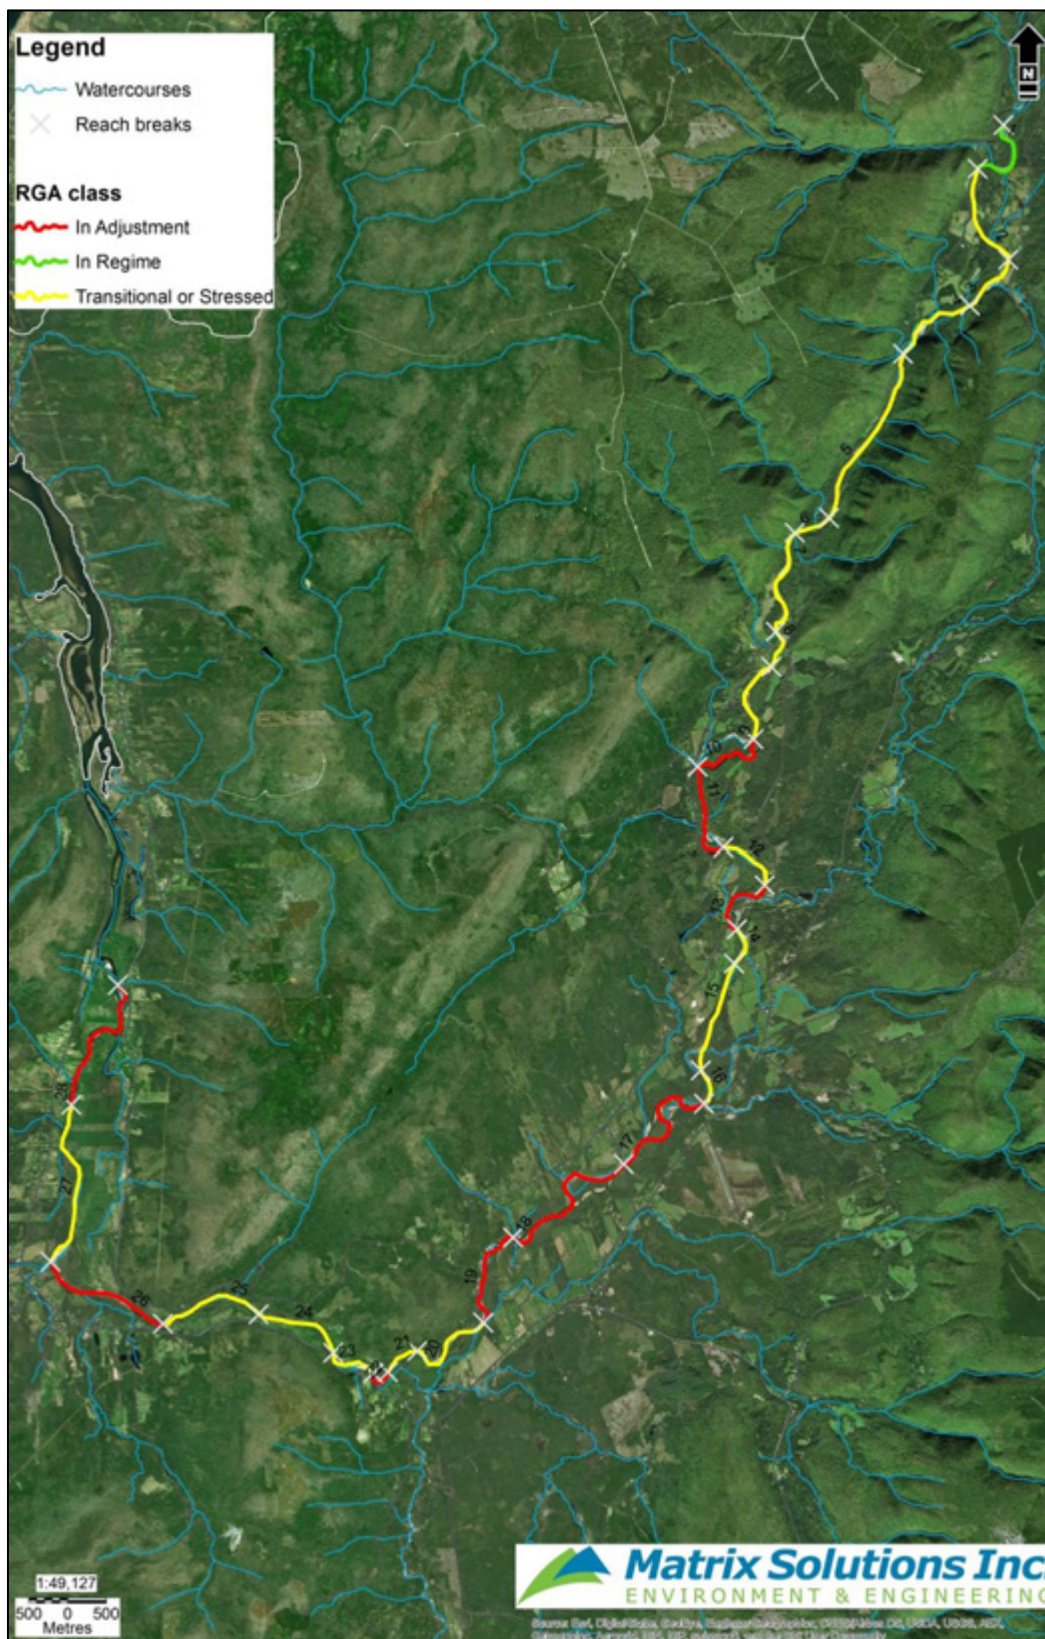
Complete results for each reach from the geomorphic assessments can be found in Appendix C. Figure 3 provides a map highlighting the RGA scores for the reaches assessed. The results of the RGA surveys indicate the majority of reaches are in a 'Transitional or Stressed' state (64%). These reaches exhibited frequent evidence of instability and are moderately sensitive to altered sediment and flow regimes which will lead to instability. Some reaches were identified as 'In Adjustment' (32%) while 4% of reaches were found to be 'In Regime'. Areas of erosion and pool habitats were also noted during the assessments, GPS coordinates for these locations can be found in Appendix D.

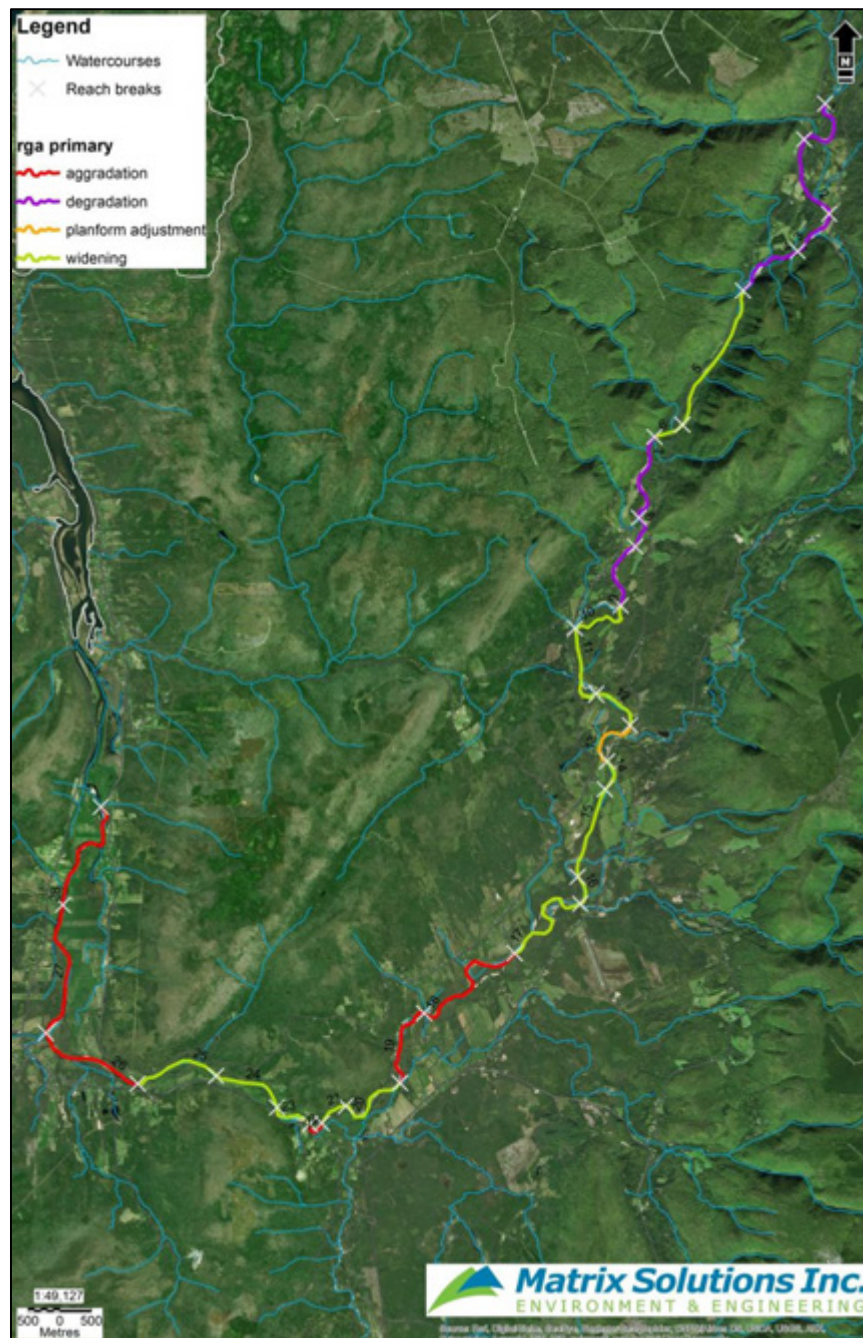
Figure 4. Margaree River geomorphic processes in assessed reaches

Widening was identified as the most common primary geomorphic process (50%), with degradation being the second most common primary process (25%) within the Margaree River watershed. Aggradation was also observed as a primary geomorphic process (21%), with 4% of reaches experiencing planform adjustment. Channel degradation appears to occur in the upper portions of the assessed reaches of the watershed whereas aggradation and widening are concentrated more centrally and at the confluence Figure 4.

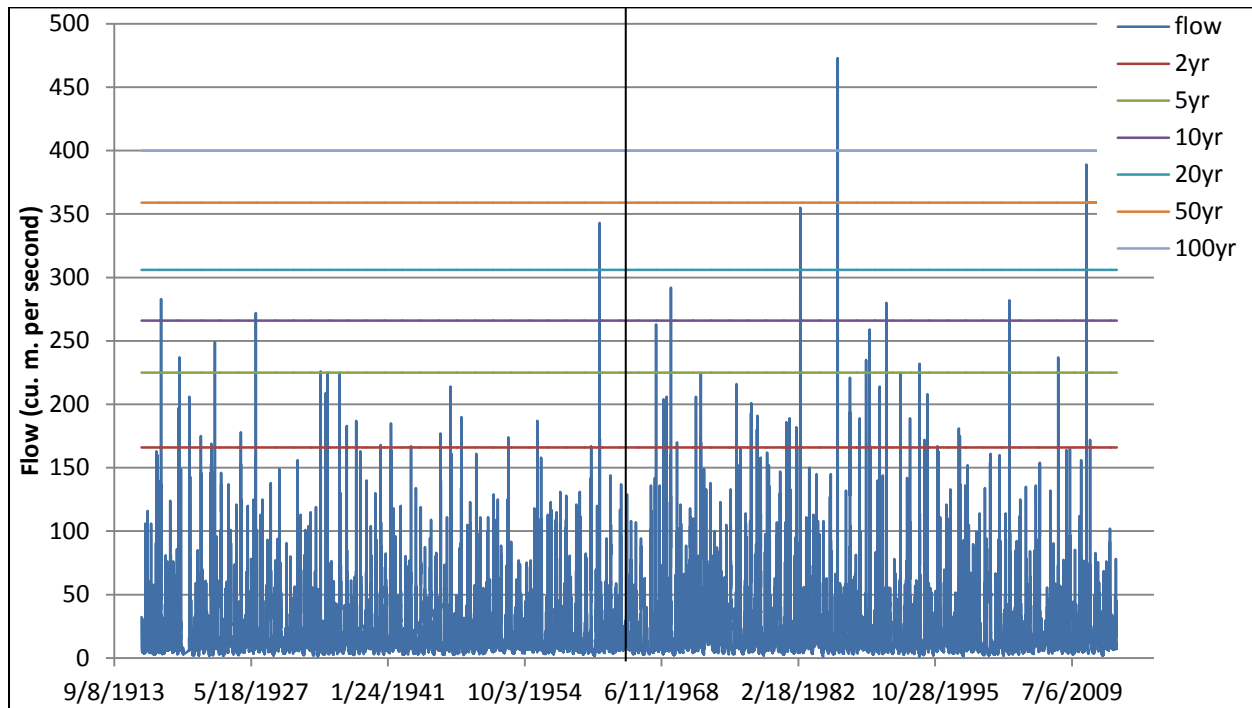
Figure 11. Daily flows on the NE Margaree River at the gauge station with flow recurrence intervals

Figure 11 compares daily flows from the gauge station (1916 to 2013) to the flow recurrence intervals.

The recurrence intervals represent a time interval over which, on average, one can expect a given flow. For the most part, the daily flows observed at the gauge station fit the number of times a flow should occur in the given time interval. For example, the number of years over which flow data was recorded is 97 years and the 100 year flow occurred once (approximately 1%). An irregularity that was noted in the daily flow data was the number of times that the 2 year flow occurred over the 97 year time span (66 times or 68%), higher than what would be expected (50%). Looking more closely at the latter half of the recorded data (mid-1964 onward – right side of the black line on Figure 7), it was found that the 2 year flow occurred 41 times or 85%; this is much higher than the expected 50%. As stated previously, changes in landuse and/or climate change may be contributing to abnormal flows. This, in turn, may be affecting stream dynamics, channel dimensions, and sediment transport causing instability as the river tries to adjust to the new flow regime.

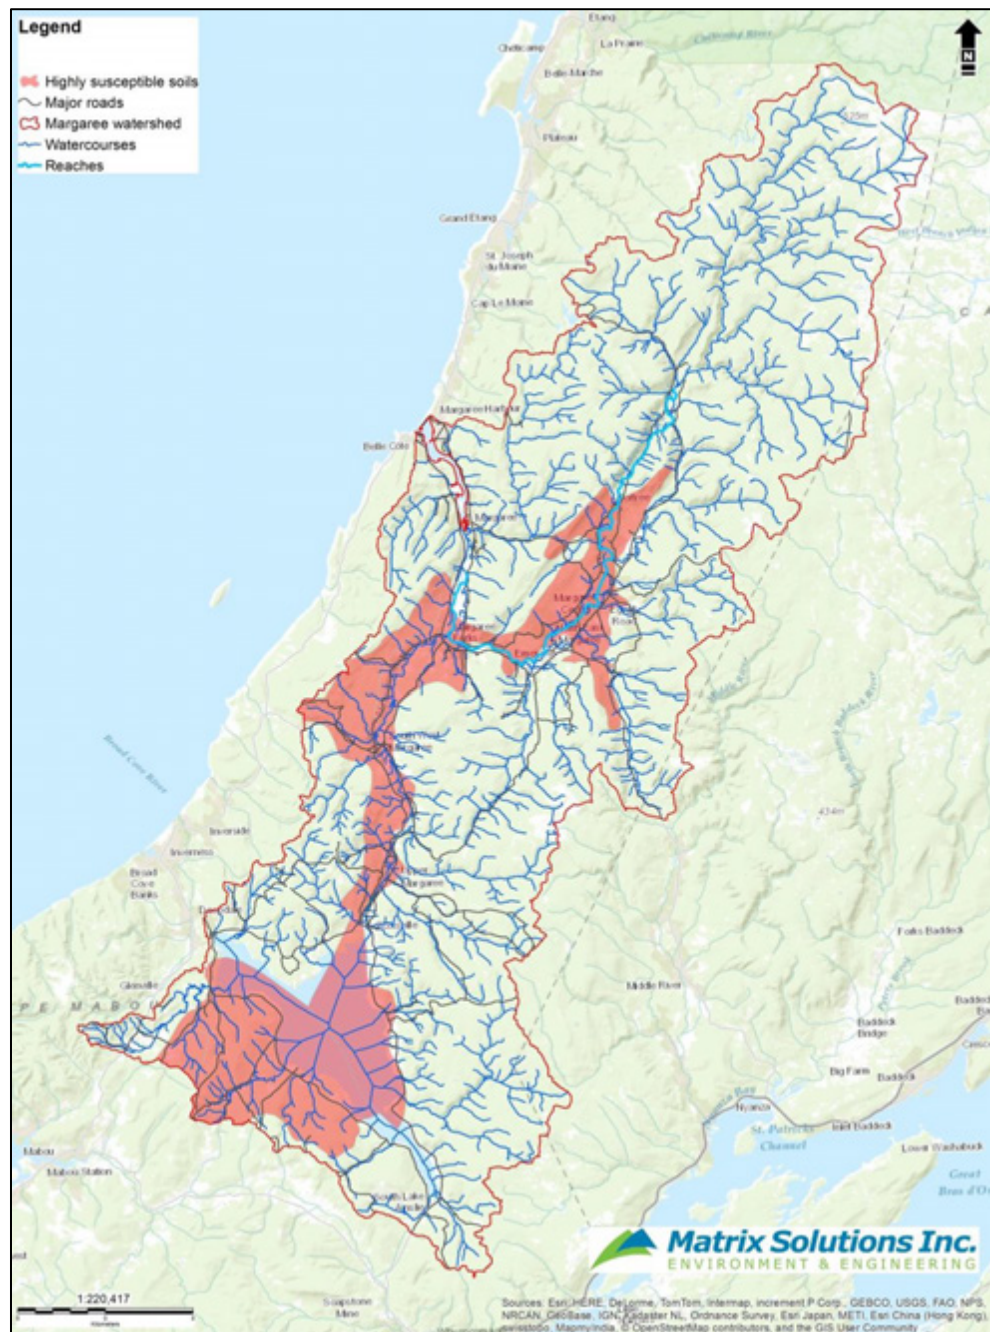
Figure 14. Highly susceptible soil groups in the Margaree watershed

According to soils data from Agriculture and Agri-Food Canada's soil landscapes of Canada (SLC) and Revised Universal Soil Loss Equation for Application in Canada (RUSLEFAC), the soils in this section of river (Portree to Cranton Crossing) are more erodible compared to soils underlying the upstream

reaches. The percent compositions of sand, silt, and clay within the soil from the SLC data give it a textural class of loam and a soil erodibility factor of 0.045 in RUSLEFAC which is classified as highly susceptible to water erosion. This soil type also underlies the remaining downstream assessed reaches (Figure 14). The comparably susceptible soils of the reaches downstream of Portree may be a contributing factor to the observed instability, since these are more responsive to extreme rainfall events and changes to flow regime.
